# Restoring Miracle 2796

*Richard Battey*

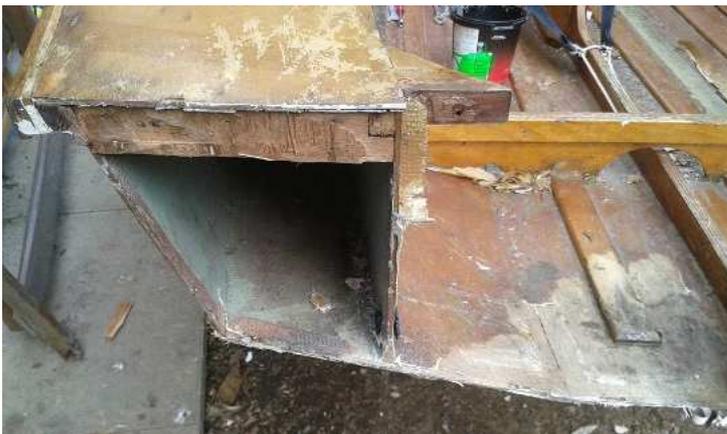
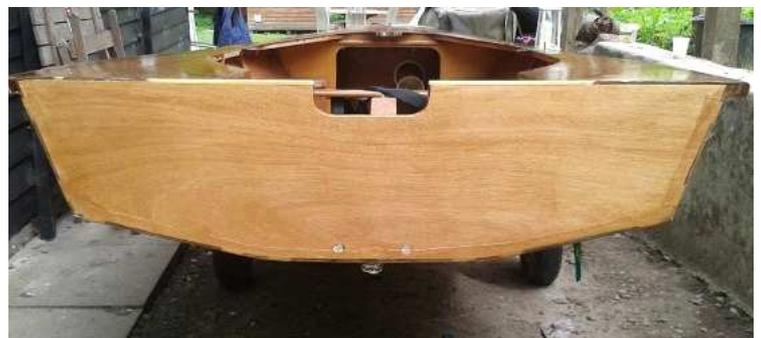
I acquired Miracle 2796 from my local sailing club (Crawley Mariners) for a very nominal sum as it was advertised in the club mag as "having seen better days". Actually when the decrepit plastic cover was removed it wasn't at all in bad shape apart from the varnish lifting, glue failure along the gunwales and a rotten transom, the latter of which did give cause for concern.

Dealing with the transom first, and not knowing much about the class having sailed Merlin's pretty much on and off for the past 20+ years, the intention was to remove the transom, or what was left of it, as delicately as possible to provide me with a template to work with. Like all well laid plans it disintegrated which left me with a head scratching moment!

With the new transom piece cut I carried out an initial fitting and marked areas that needed adjustment carefully using a block plane. Once done, and I was happy with the fit, I mixed up some SP106 epoxy with West microfibres and created a neat fillet around the inside edge and applied epoxy to all keyed/ structural surfaces adjoining hull, side decks/tanks and clamped in place. Any gaps were taken up with epoxy/ microfibre mix. Once the epoxy had cured, I set about sanding edges making sure I created a neat and tidy profile. Satisfied that the new transom and joints were fair I applied some plain weave 50mm glass cloth (175gm/sq.m) to the outside and inside edges of the transom to create structural re-enforcement. Once cured, some significant sanding took place before I applied a coat of SP106 resin to the transom inside and out to provide additional weathering properties. Job done!

I purchased a sheet of 2.5m x 1.2m, 5mm gaboan marine ply from Wenban-Smith and set about marking up

the new transom (including slot tabs to be on the safe side). A little tip when cutting ply, run masking tape along the pencil line so that when you cut with your jigsaw it does not splinter the wood. It works!
